Rosehill Reservoir, Toronto

HERITAGE IMPACT ASSESSMENT

DRAFT FINAL JUNE 6, 2016

Prepared for
CITY OF TORONTO, ENGINEERING AND CONSTRUCTION
SERVICES

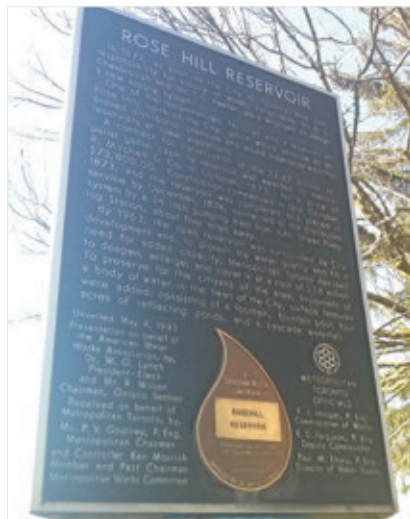
FIGURE 3
AWWA Landmark Recognition Plaque
on site at Rosehill Reservoir.

The Rosehill Reservoir was so recognized in 1981. A bronze plaque bearing this designation stands on the site's Rosehill Avenue frontage, approximately 20 m east of the Cascade Entrance [fig 3]. The site is one of four AWWA-recognized locations in Toronto, together with the John Street Pumping Station (1981), the Island Filtration Plant (1983), and the R.C. Harris Water Treatment Plant (2014).

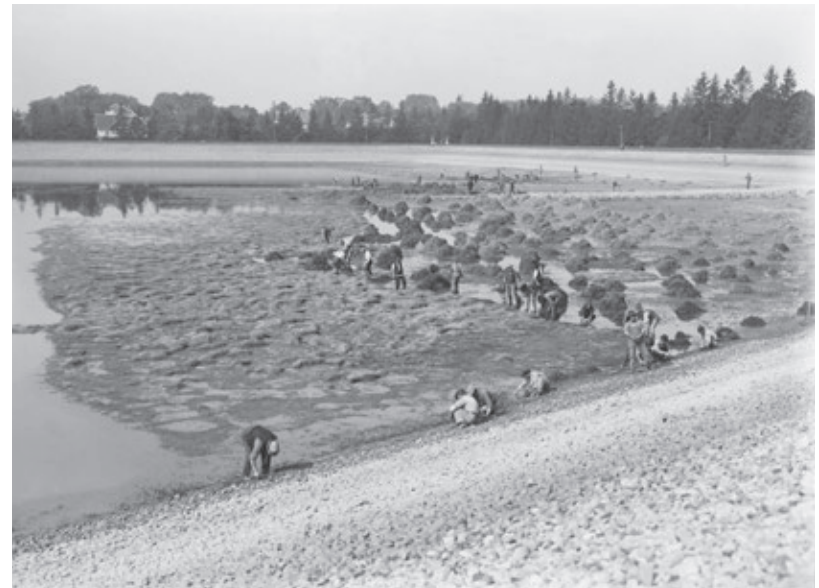
FIGURE 22 (TOP RIGHT)

Cleaning the Rosehill Reservoir, c. 1922.

High public drinking water demand restricted the city’s ability to empty the reservoir for cleaning [fig 22], let alone to take the facility offline for more significant maintenance and upgrades. Installation of an expanded pair of water mains (two 36” mains, replacing one original 24” main) to feed the reservoir, first planned in 1905, was finally carried out in 1922 [fig 23]. Planned cleanings that would have included the installation of the new mains had to be

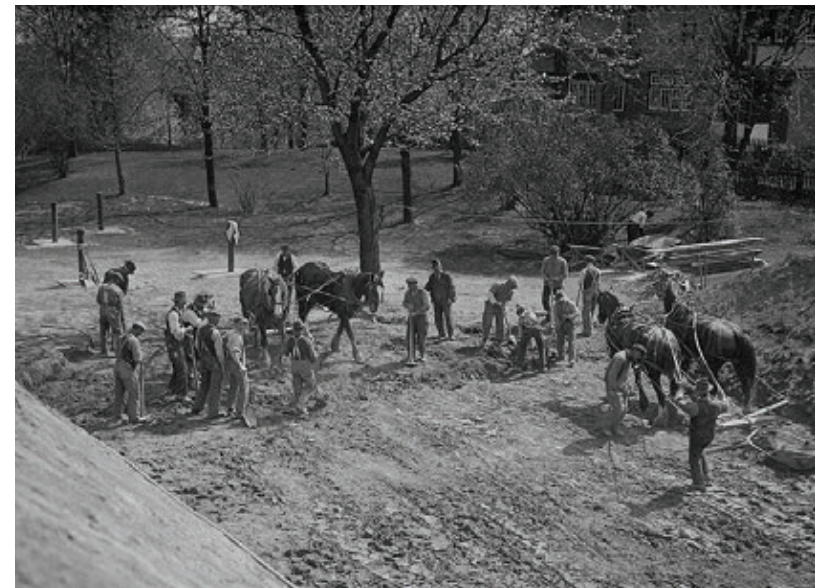
FIGURE 23 (BOTTOM RIGHT)

Excavation through the south berm of the reservoir for installation of new 2x36” watermain connections, 1922.

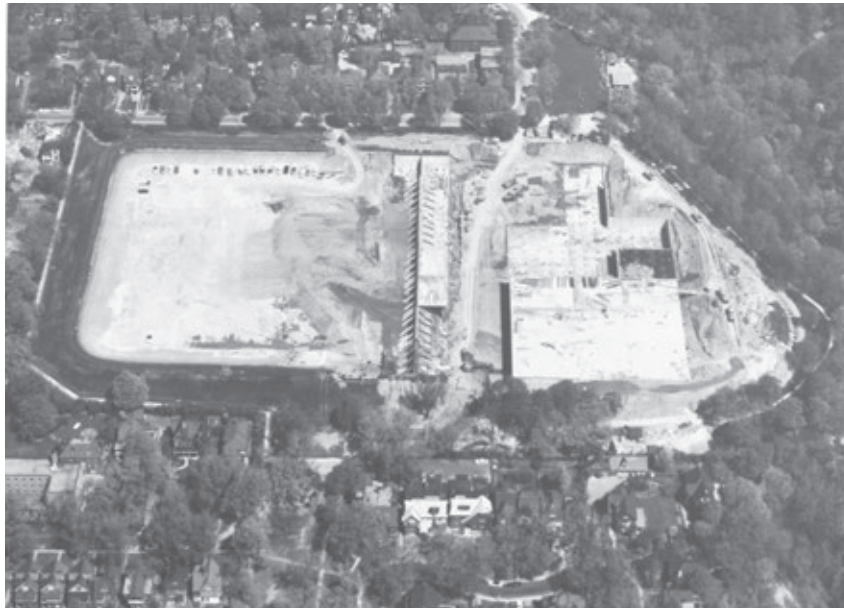
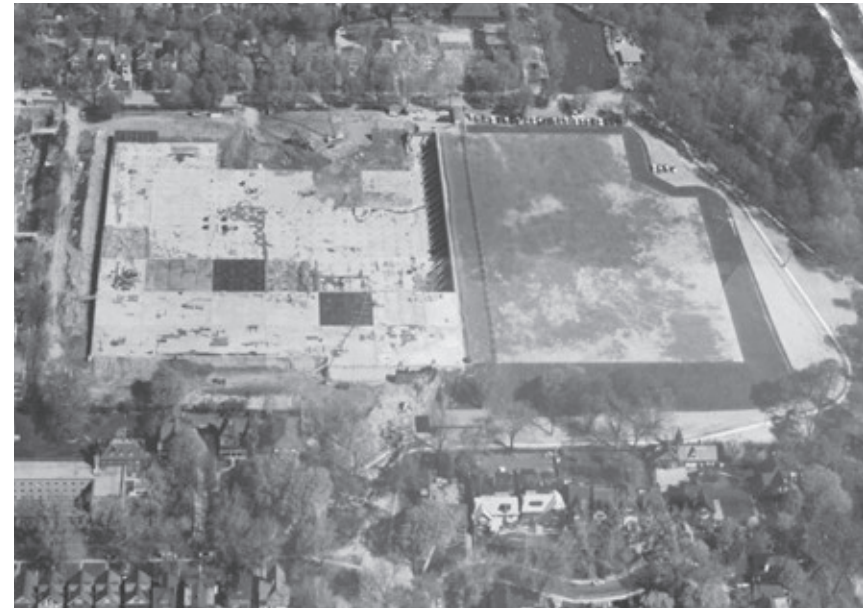
FIGURES 25 AND 26

tailed a substantial disruption of the previous terrain and landscape of the open-topped reservoir. While writers covering Rosehill’s history have referred to the reservoir as having been ‘deepened’ and ‘covered over’, the reality entailed the removal of the existing reservoir and berm and the construction of a completely new, two-compartment concrete reservoir on a modified footprint, with brand new earth slopes surrounding it [fig 25 and 26].

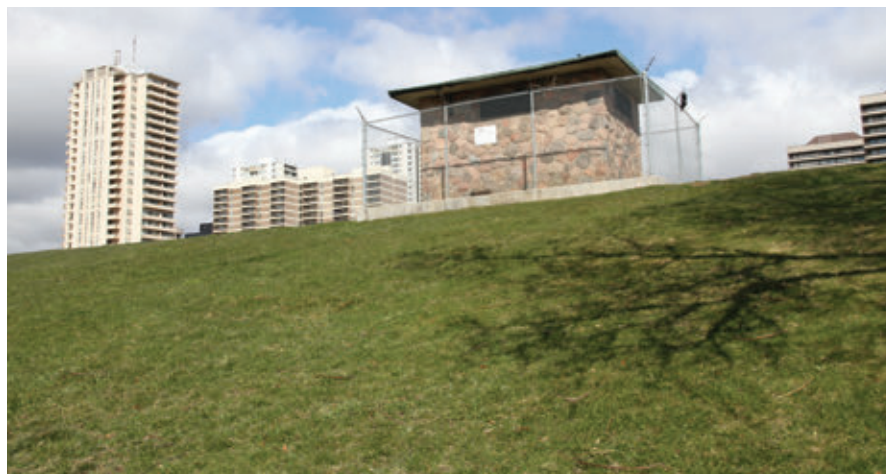
40

The smaller Access House is located above the Valve House, on the edge of the reservoir roof [fig 40]. It consists of a simpler rectangular design, topped with a spare but attractive flat roof with copper flashing (possibly original),

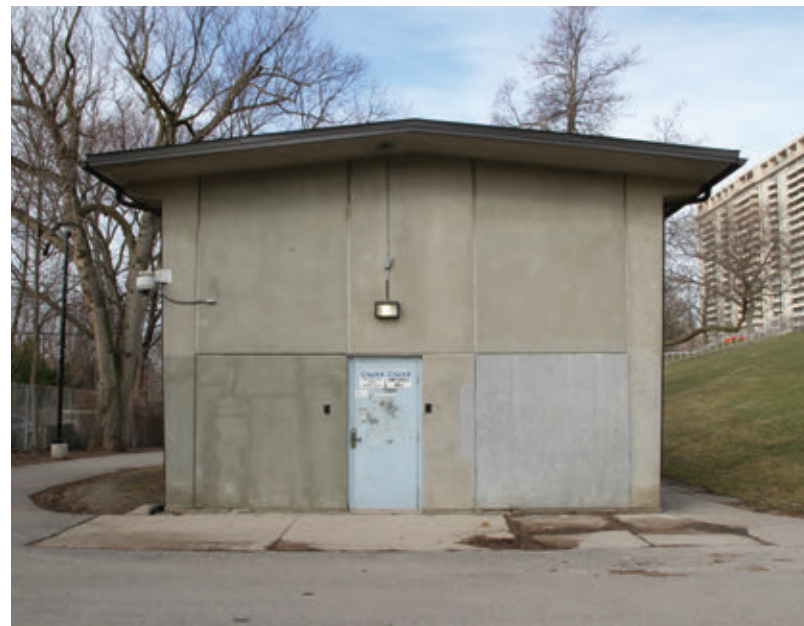
The Valve House is located below the reservoir, and features concrete pilasters and projecting concrete eaves that shelter garage and personnel doors at each end of the structure [fig 36]. The north and south faces of the building are finished with splitface granite field stone between the pilasters [fig 37], while the east and west ends are spare concrete [fig 38 and 39]. The in-

side walls of the structure are finished in brick. The Valve House exterior is in generally good condition, although the concrete faces at the east and west ends of the structure have been marred by the addition of poorly placed and selected wall pack lights and CCTV cameras. The roof and flashing have been replaced with unattractive brown material that does not match the original copper materials on the adjacent Access House.

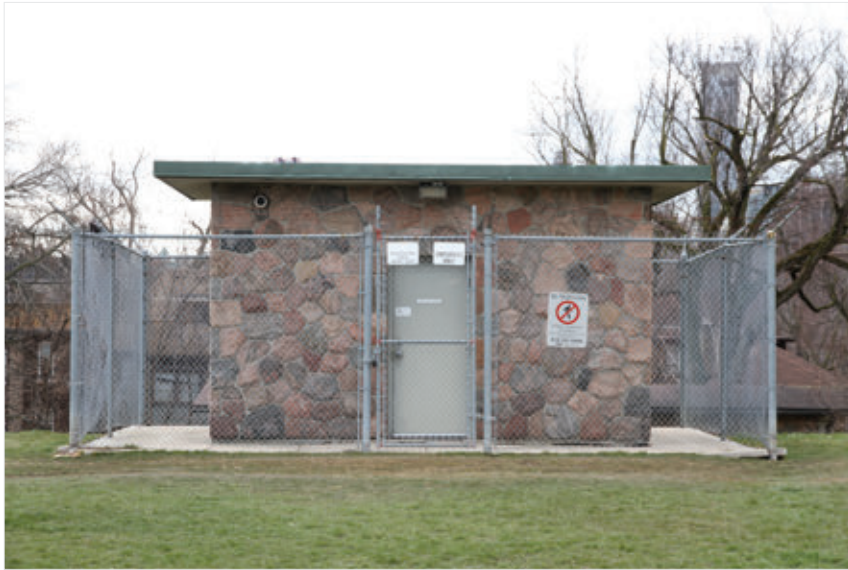
and faced in splitface granite on all four sides [fig 41 and 42]. The Access House is surrounded by disintegrating concrete slabs and an unattractive and deteriorated 8' (2.4 m) frost fence and barbed wire that is a modern addition to the site.

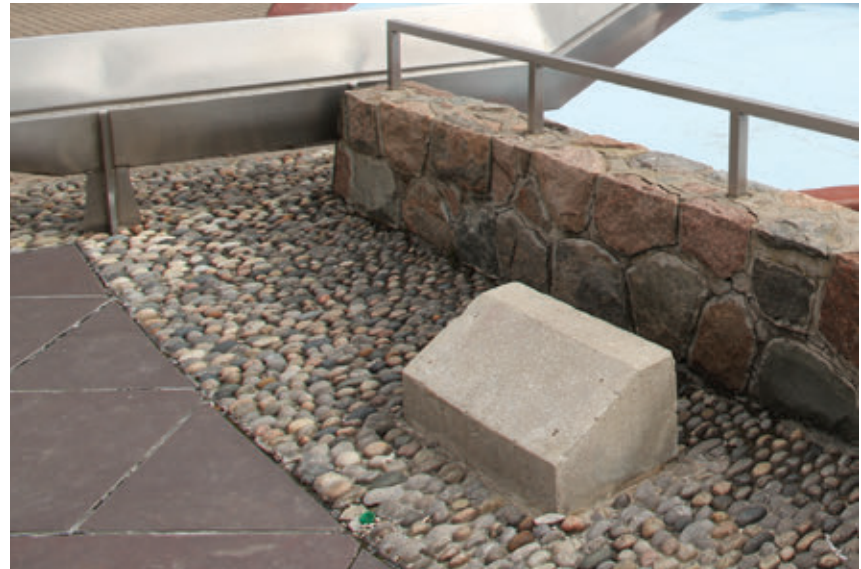
49

The two etched plaques, believed to have been stainless steel, that originally interpreted the monument site and sculpture are no longer present at the site. The "landscape plaque" [fig 50] was mounted above the precast concrete bench on the equipment enclosure, while the "sculpture plaque" [fig 51] was located on a small podium on the platform [fig 49].

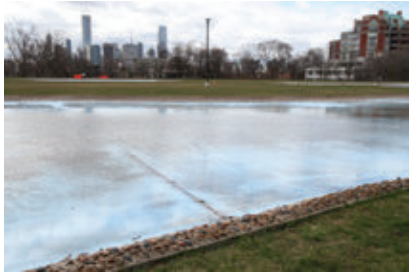
52

The reflecting pools consist of three broad concrete basins [fig 52], linked in sequence by narrow connecting chan-

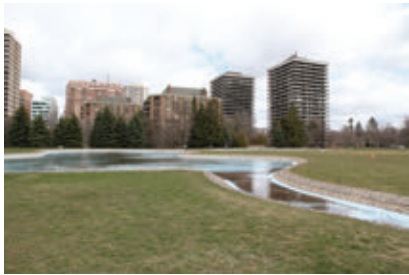
53

nels [fig 53] and terminating at the ornamental bridge [fig 54] that separates the pools from the Cascade. Together, the three shallow basins and their connecting channels occupy an area of approximately 3550 m². The sequence is laid out to provide an inferred visual connection from the fountain pool located beneath the water molecule sculpture, through the reflecting pools, to the cascade, although in practice each component was a separately pumped water feature. Above the former water's edge of the reflecting pools, a border of handset cobbles (large, multicoloured riverstone pebbles) in two distinct orientations are embedded in the concrete [fig 55].

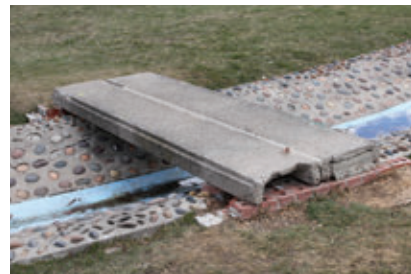
56

Two concrete slab footbridges, perched on masonry footings, originally crossed the reflecting pools at the channel locations. One of these footbridges is missing, while the other has been damaged and appears to be sitting loosely on its footings [fig 56].

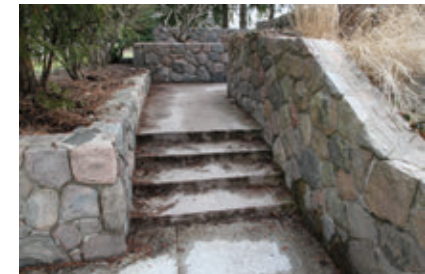
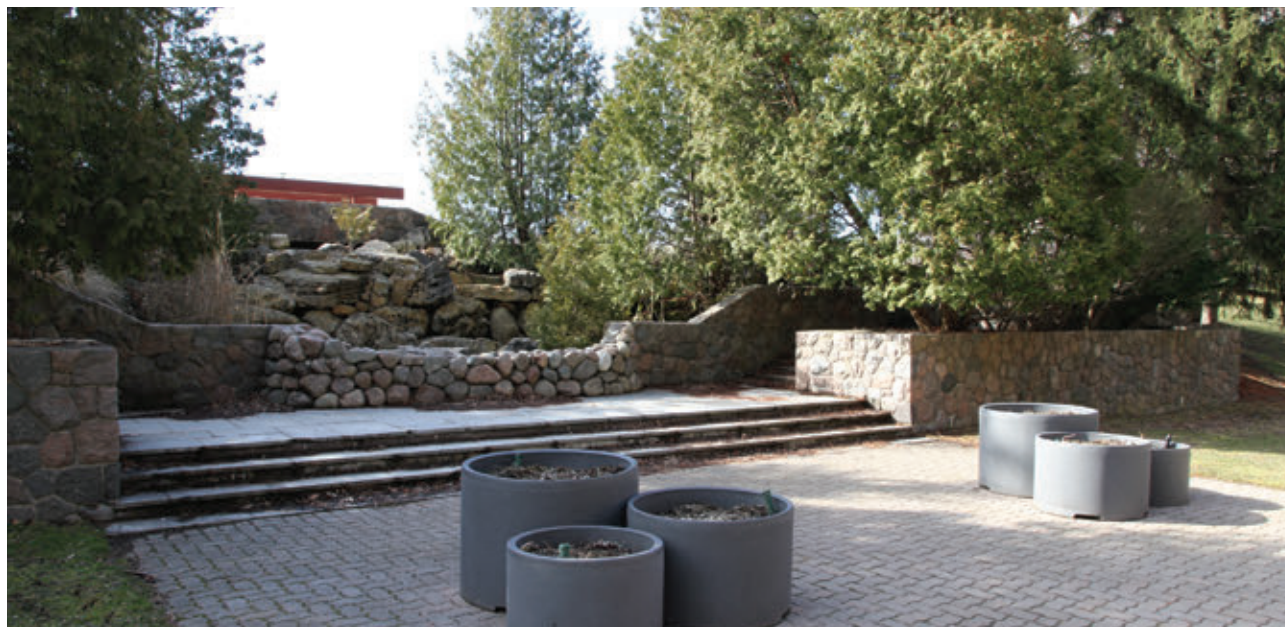
A pair of tree specimens with a weeping form visible in 1967 photographs [fig 59 and 60] of the original landscape installation are not present at the cascade today. The original photographic prints are not well enough resolved to determine if the cedars that now play such a prominent part in the material structure of the cascade garden were included in the original design or represent a later replacement.

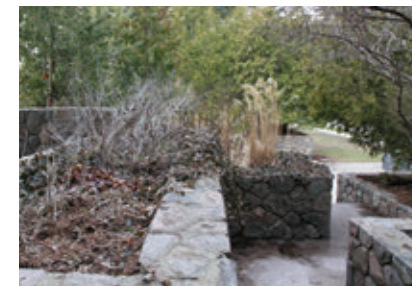
57

in quarry tile similar to that used in the original covered plaza that wrapped around the monument, and the western cascade staircase is still surfaced in this material, though it is deteriorating [fig 61]. On the eastern stairs, the tile has been removed, leaving the bare concrete steps [fig 62]. The split-face granite walls are cracked and broken in a number of locations [fig 63], and recessed lighting incorporated in these walls appears inoperative. The water cascade is understood to have not been operational for a number of years.

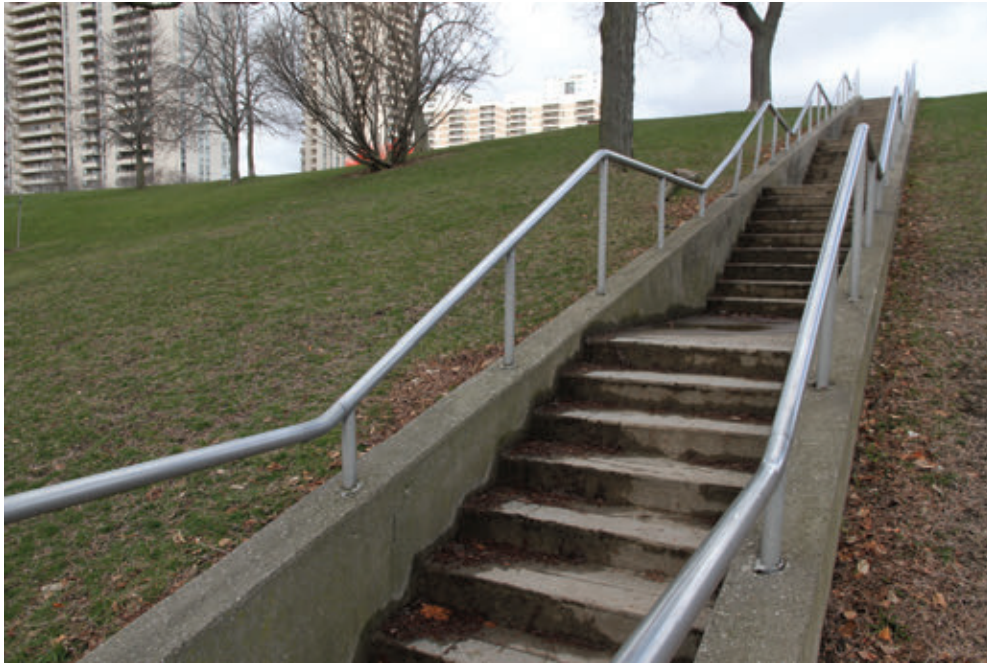
The two sets of concrete stairs built c. 1966 as part of the construction of the covered reservoir are in fair condition [fig 64 and 65]. Much of the original tile nosing on the steps has been replaced using inconsistent styles and colours of tile [fig 66]. The twin metal railings, the signature architectural feature of each stair set, are in good condition, although the waterproofing of their anchor points in the concrete cheek walls of the south stairs should be renewed [fig 67]. Each railing consists of three or more longitudinal sections which are fit together by way of lap joints [fig 68].

The concrete steps and interior surfaces of the cheek walls are in generally good condition, although marred by the inconsistent replacement tiles that have been installed on the stair nosings.

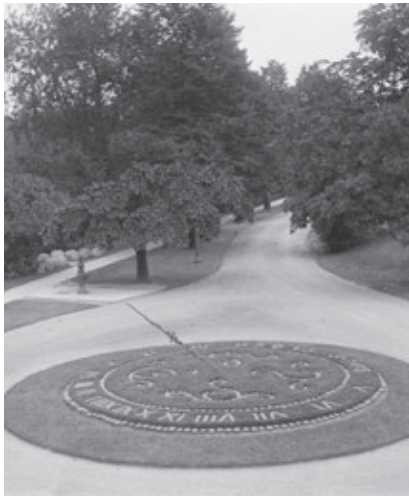
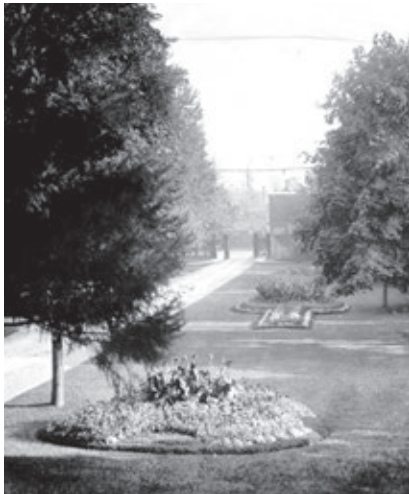
INSET

Figures 17 and 18. For larger reproductions, see pages 21-22.

trance was originally embellished with a floral clock [fig 18] and other planting beds, and the "Little Park" entrance at Summerhill Avenue was pictured in 1913 with gates and a line of mounded beds parallel to the entrance road [fig 17]. Returning more extensive garden beds to the perimeter landscape and the "Little Park" would restore the park's original character of a promenade garden, and it is suggested that opportunities be explored to engage interested community members to participate in curating and maintaining plantings in these areas, in coordination with Parks, Forestry and Recreation division.

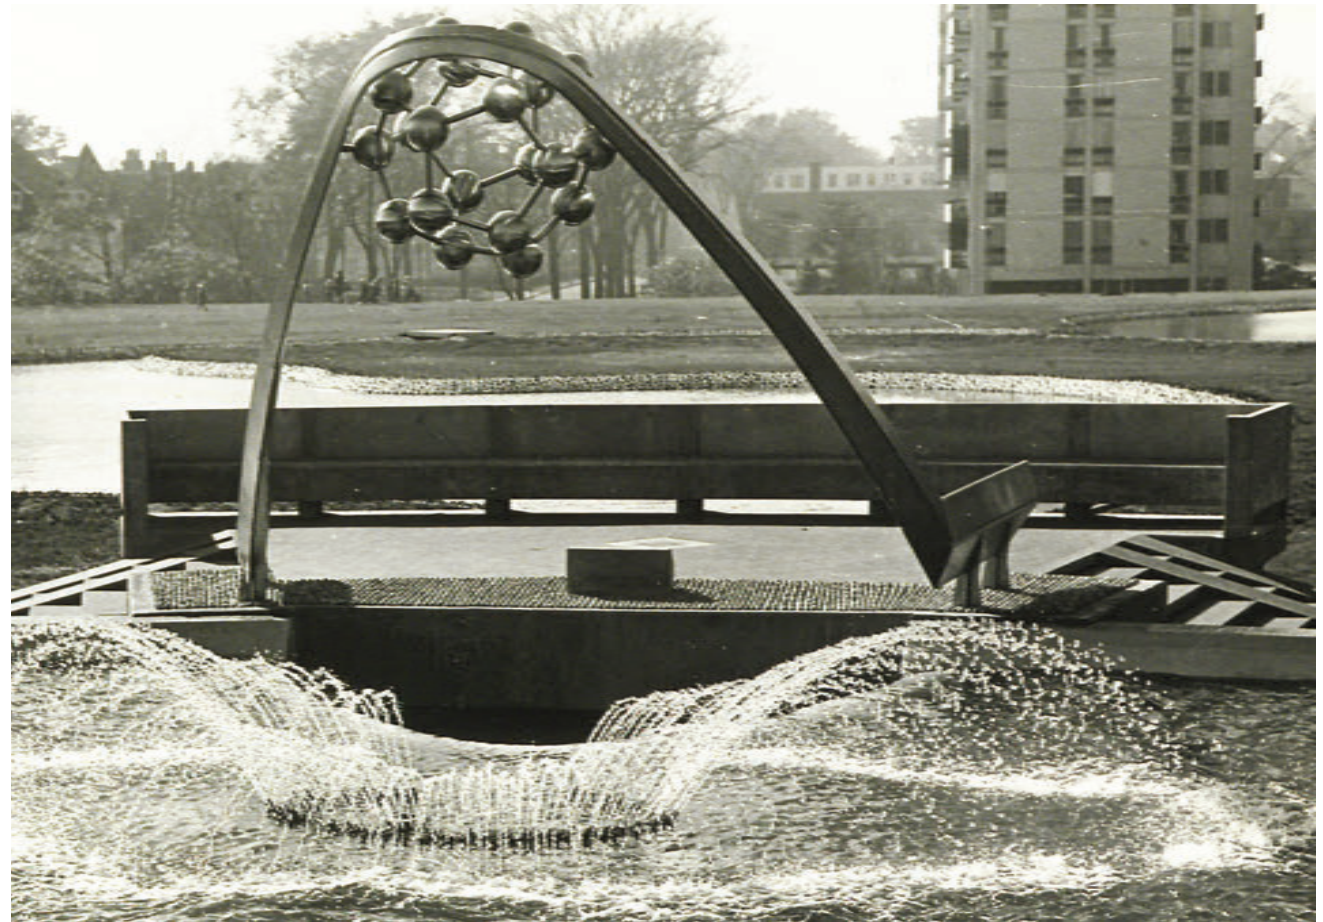
80

The complete stainless steel sculpture, including wings, parabolic arch and "water molecule", is a conservation priority [fig 80]. The reservoir rehabilitation work will include the demolition of the existing concrete platform and parapet to which the sculpture is anchored, requiring that the sculpture be carefully separated from the concrete and relocated prior to the commencement of demolition. It may be necessary as part of this work to remove and replace the four stainless steel anchoring bracket footings for the sculpture. The removal, transportation, conservation, and restoration of the sculpture to the site should be undertaken by specialists with prior experience in the relocation and conservation of stainless steel public artworks.

Reinstatement of the sculpture, logo panel, and interpretive plaques should be accomplished in a manner that clearly groups these features as elements of a Centennial monument, and that reinstates their context as defining elements of a hard-surfaced public plaza or public facing of the Rosehill Reservoir.

The raised orientation of the sculpture, and the two principal views of the molecule—from below front and from the back (inside of the parabolic arch)—are critical elements of its original design intent [see fig 88, page 53], and it is essential that this orienta-

tion and these views of the molecule be maintained in the sculpture’s new location.

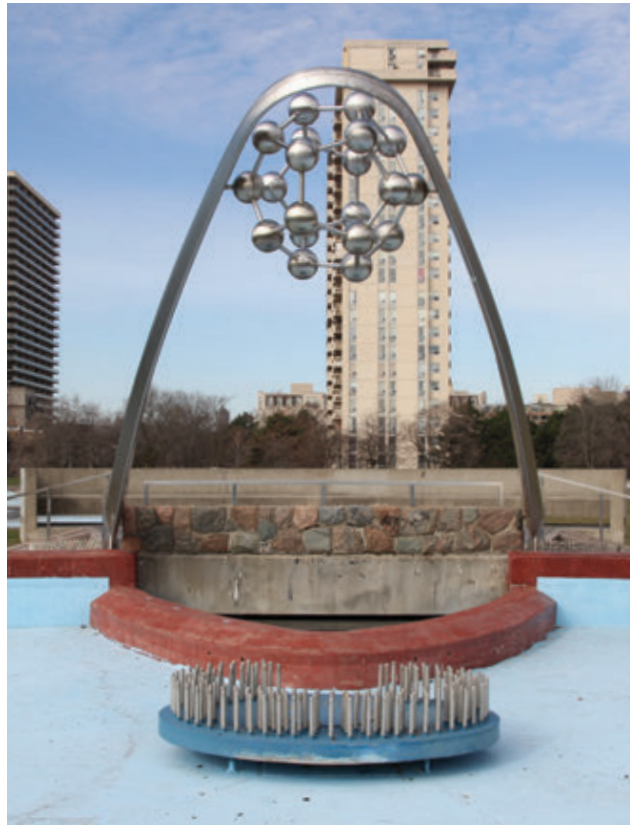
DESIGNED VIEW #1:
VIEW FROM BELOW FRONT

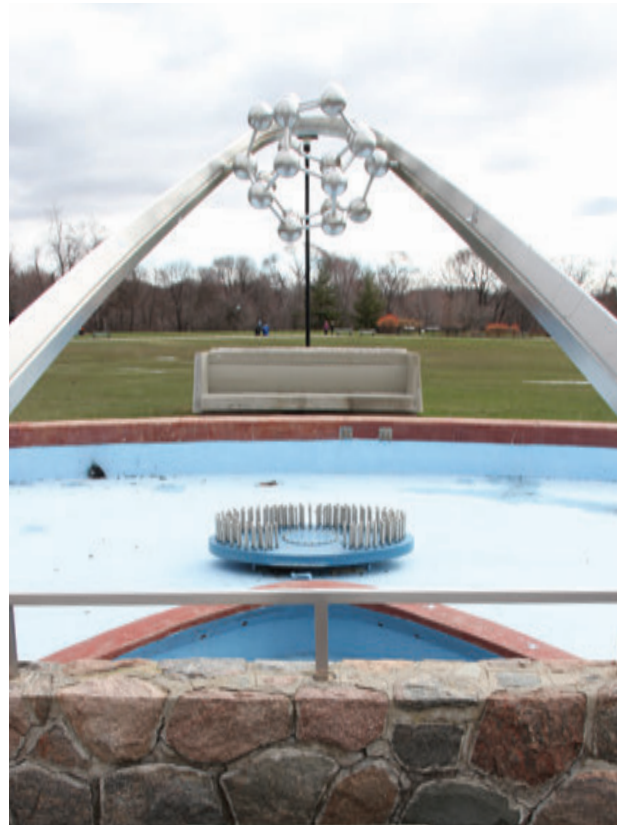
DESIGNED VIEW #2:
VIEW FROM PARABOLIC INTERIOR
